Monthly Oversight Report 12  
ACS NPL Site  
Griffith, Indiana  
December 1 - December 28, 2001

Subject: Monthly Oversight Summary Report  
No. 12 for December 2001

**Monthly Oversight Summary Report No. 12**  
**ACS Superfund Site WA57, 46526.238**

**Reporting Period:** Month of December (December 1 - December 28, 2001)

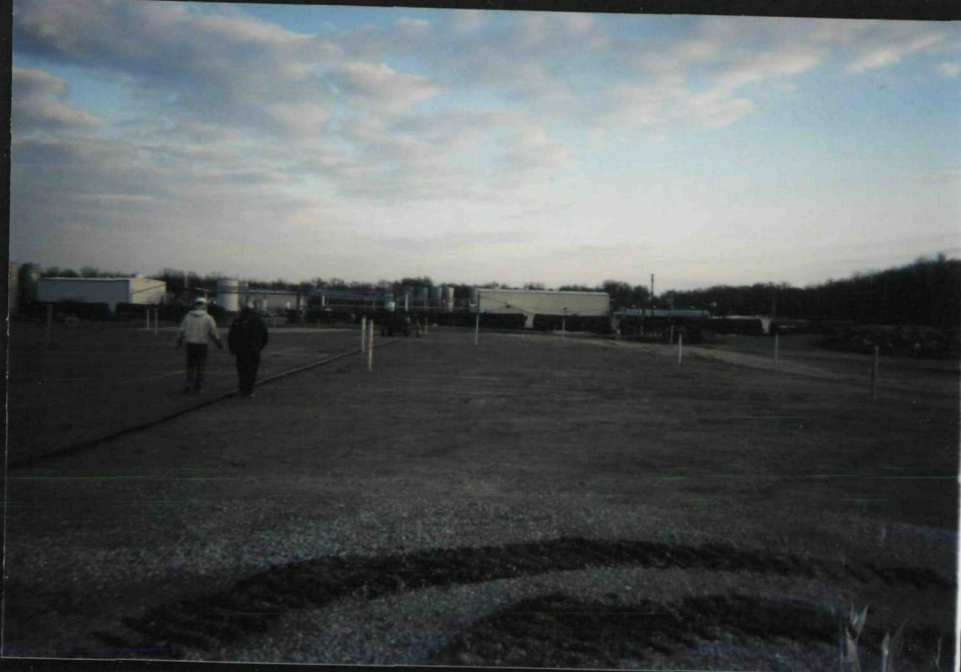
Site: American Chemical Services, Inc.  
 Proj. #: 46526  
 Roll: 16 Photo #23  
 Date: 12-04-01 Time: 07:45  
 Photographer: Leigh Peters  
 Description: Photo facing north showing Heritage Industrial Services straightening coiled pipe for OFCA ISVE yard piping installation.

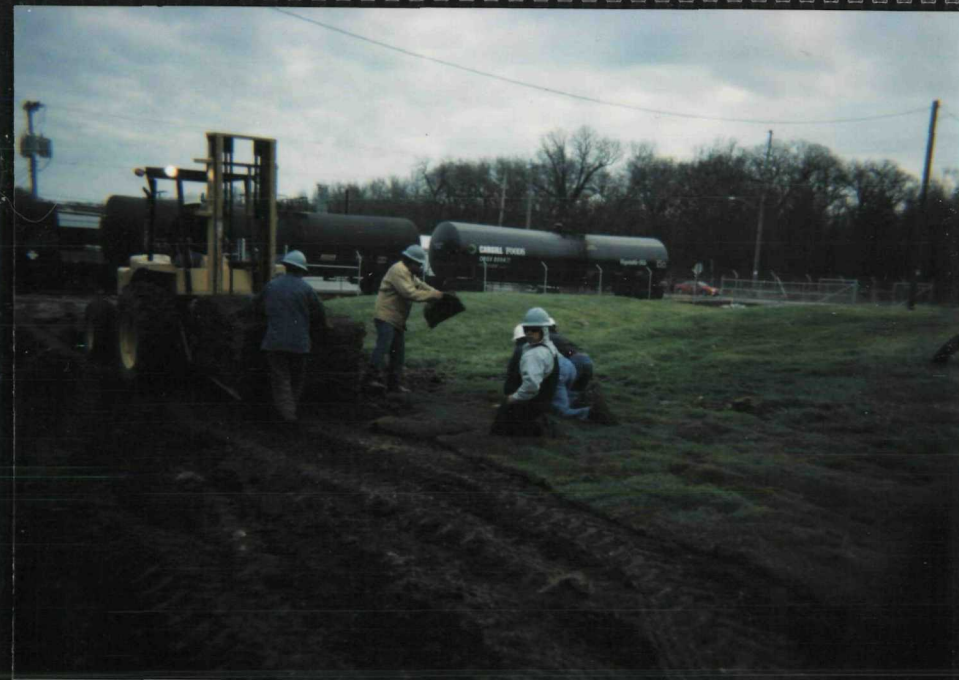
Site: American Chemical Services, Inc.  
 Proj. #: 46526  
 Roll: 16 Photo #24  
 Date: 12-04-01 Time: 08:20  
 Photographer: Leigh Peters  
 Description: Photo facing northeast showing Slusser's laying sod near OFCA extraction well EW-20C.

BVSPC observed Slusser's place sod near extraction well EW-20C located on the OFCA. Tom Tinics of MWH stated that Slusser's did not appropriately groom the topsoil in the vicinity of extraction well EW-20C prior to laying the sod. Slusser's returned to the site and rolled the sod in order to improve the grading and grooming near extraction well EW-20C.

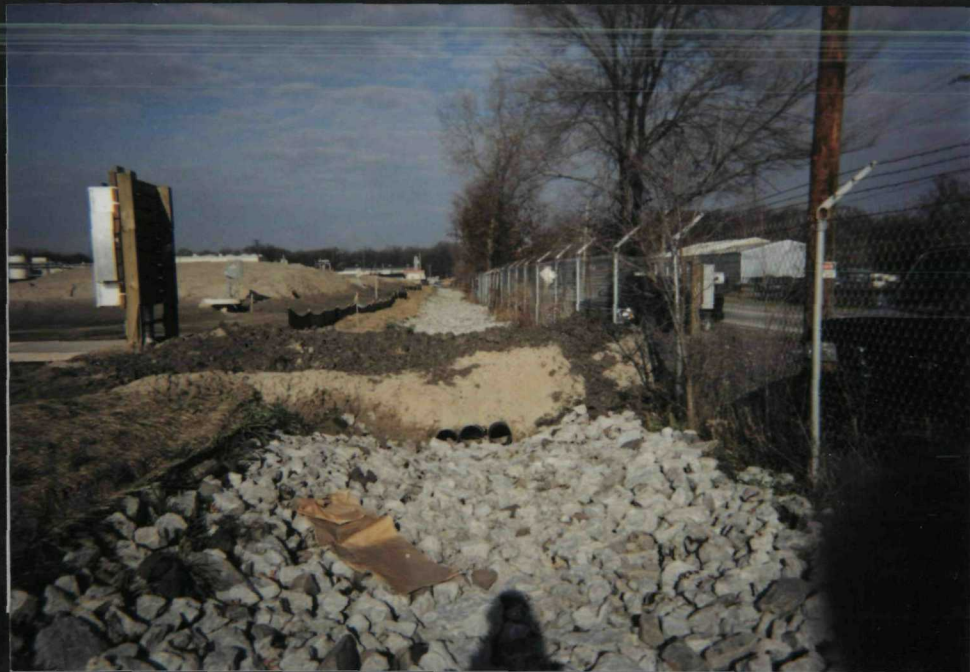
Site: American Chemical Services, Inc.  
 Proj. # 46526  
 Roll: 16 Photo #25  
 Date: 12-04-01 Time: 13:30  
 Photographer: Leigh Peters  
 Description: Facing north showing culvert piping  
 placed underneath buried electrical line  
 and earthen berm in swale 3, near Colfax  
 Ave.

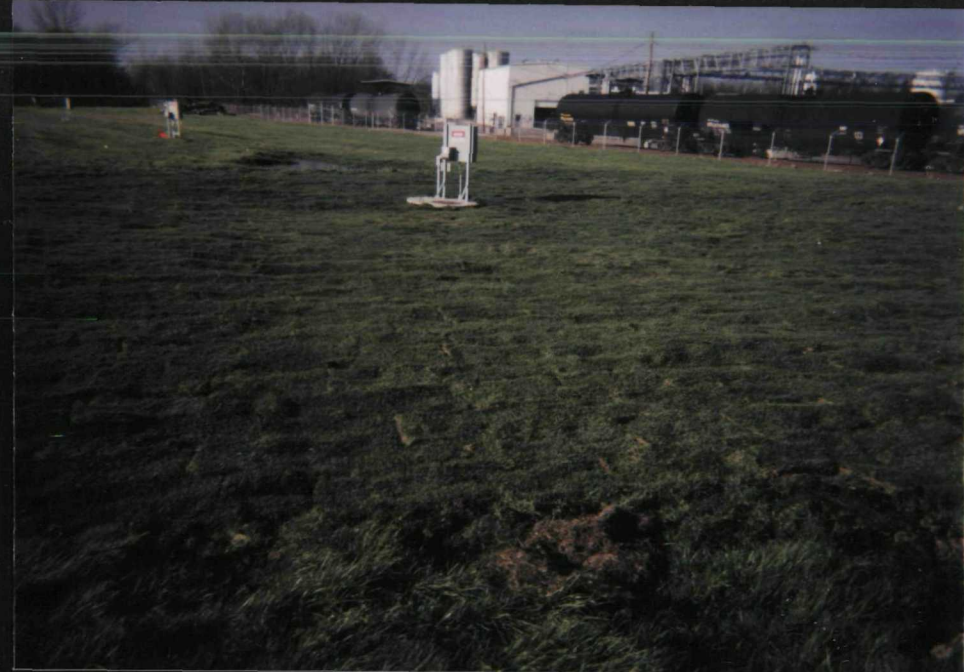
Site: American Chemical Services, Inc.  
 Proj. # 46526  
 Roll: 16 Photo #26  
 Date: 12-04-01 Time: 13:35  
 Photographer: Leigh Peters  
 Description: Photo facing northwest showing sod  
 placed near OFCA extraction well EW-  
 20C.

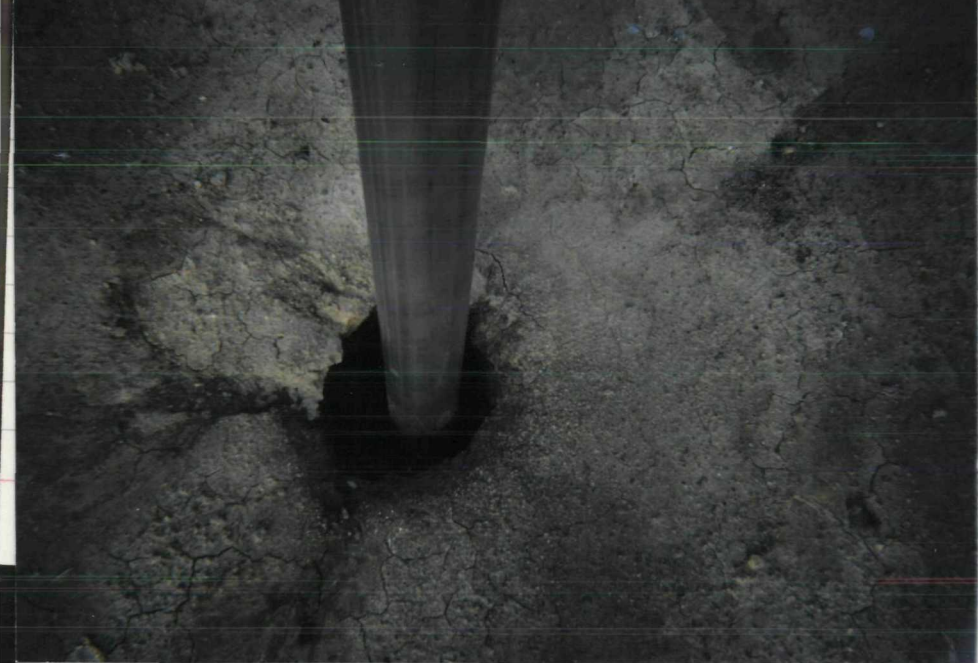
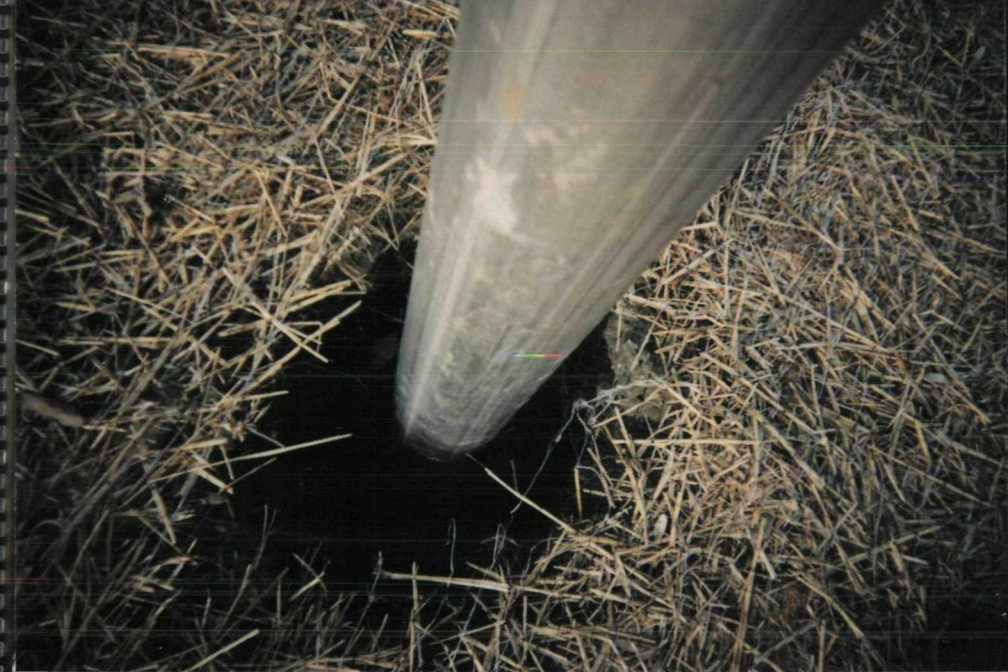
MWH reported that the grout and bentonite had settled around OFCA ISVE wells SVE-25 and SVE-41. MWH did not know how deep the grout had settled; however, it reported that the wells would be regouted and repaired as part of the OFCA ISVE yard piping installation activities.

Description: Photo facing northwest showing settled  
grout around OFCA ISVE well SVE-41.

C. Daly also reported that HIS put bentonite into SVE BS and 41 to replace settled grout.

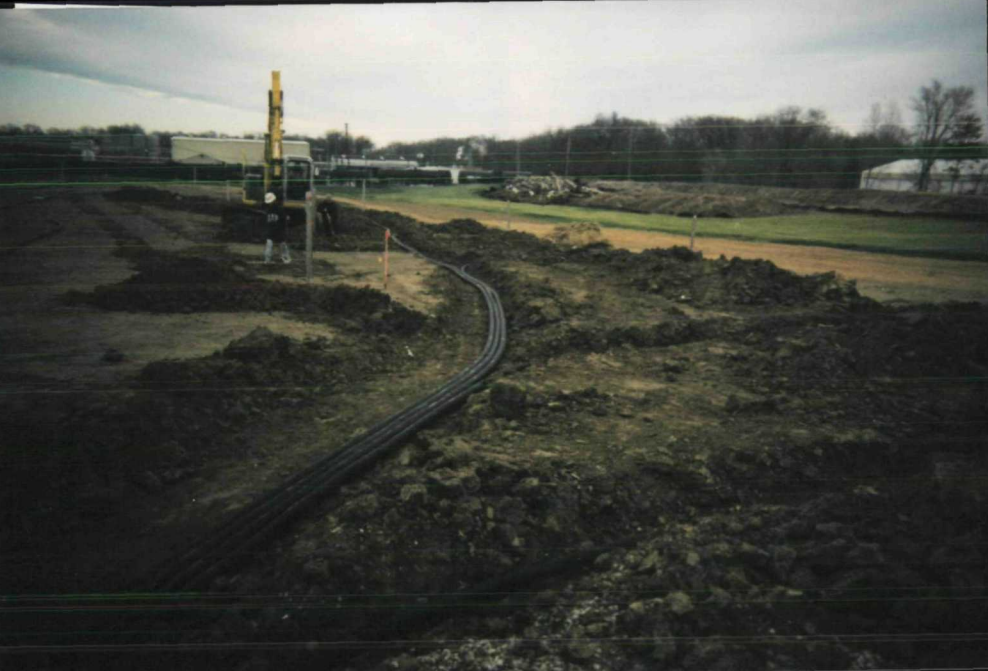
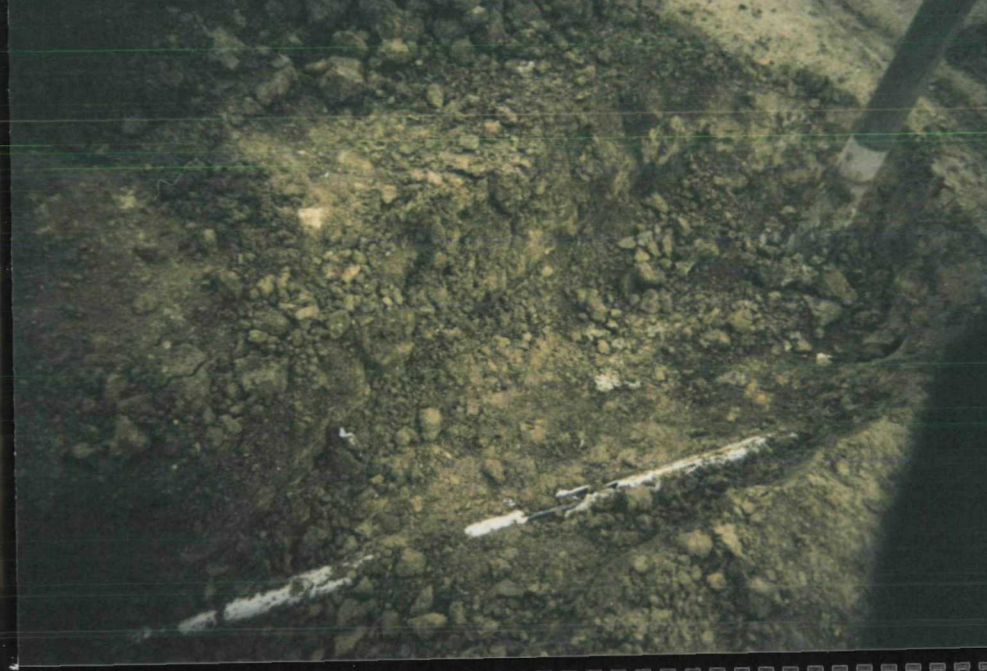
HIS encountered an underground electrical conduit that connects the blower shed and the Barrier Wall Extracation Wells on December 6, 2001. The electrical lines in the conduit had been turned off for safety; therefore there were no injuries. The lines will be repaired. No other health and safety issues occurred during the past week.

0805 HIS damaged electrical conduit at SVE 34.

Description: Photo facing northwest showing damaged electrical conduit at SVE-34.

MWH reported that Austgen repaired the electrical conduit located between the OFCA blower shed and extraction well EW-20C that had been damaged by HIS during piping installation activities.

1325 Roll 17 Photo 14 facing southeast showing  
repaired electrical conduit at SVE-34  
Observed HIS excavate, install saddles and  
flanges

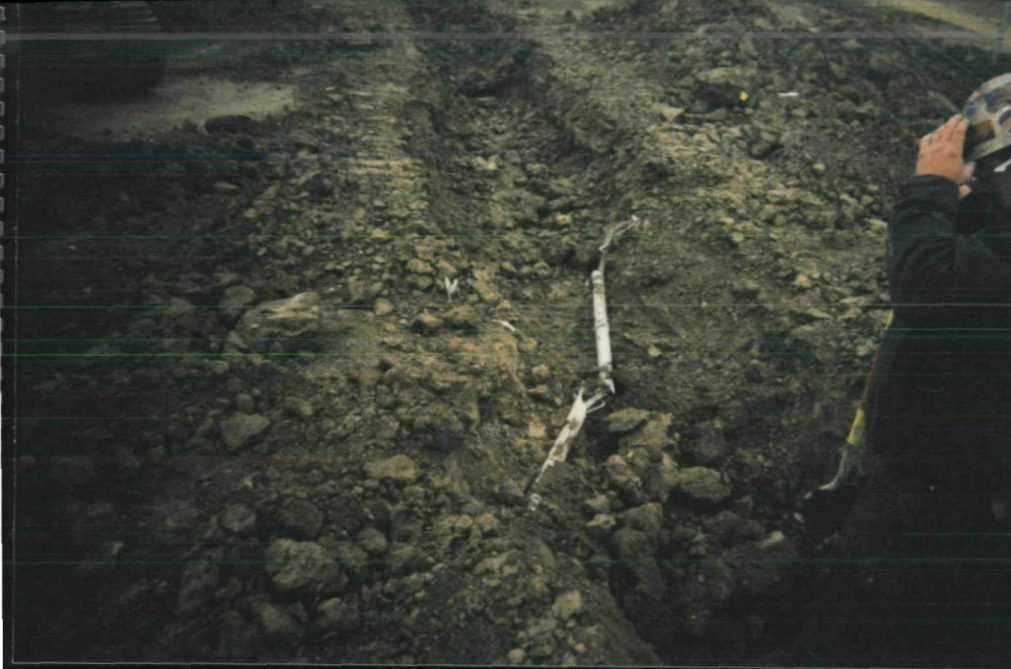
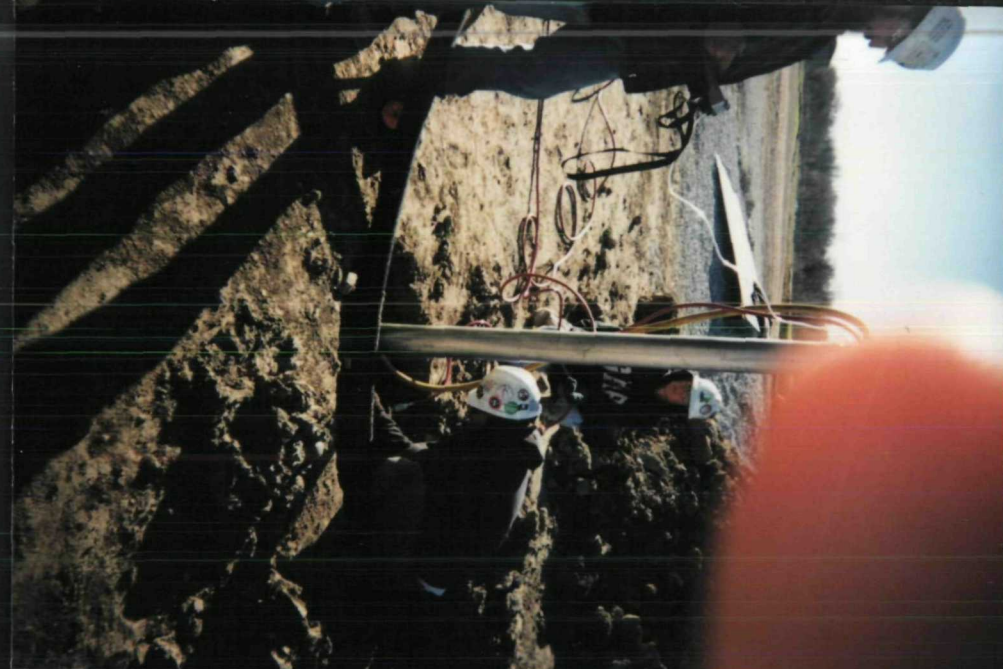
BVSPC observed HIS inert the ISVE wells in order to connect the saddles for the piping installation. HIS used a "muni-ball" plug to seal the well below the saddle connection point. Once the saddles were connected and sealed, HIS removed the "muni-ball" and replaced the cap on the well. HIS performed pressure testing on the lines prior to installation. HIS was required to maintain 50 psi of pressure for a minimum of 5 minutes in the lines for the pressure test.

Description: Photo facing southwest showing HIS inerting well in order to drill hole for piping connection.

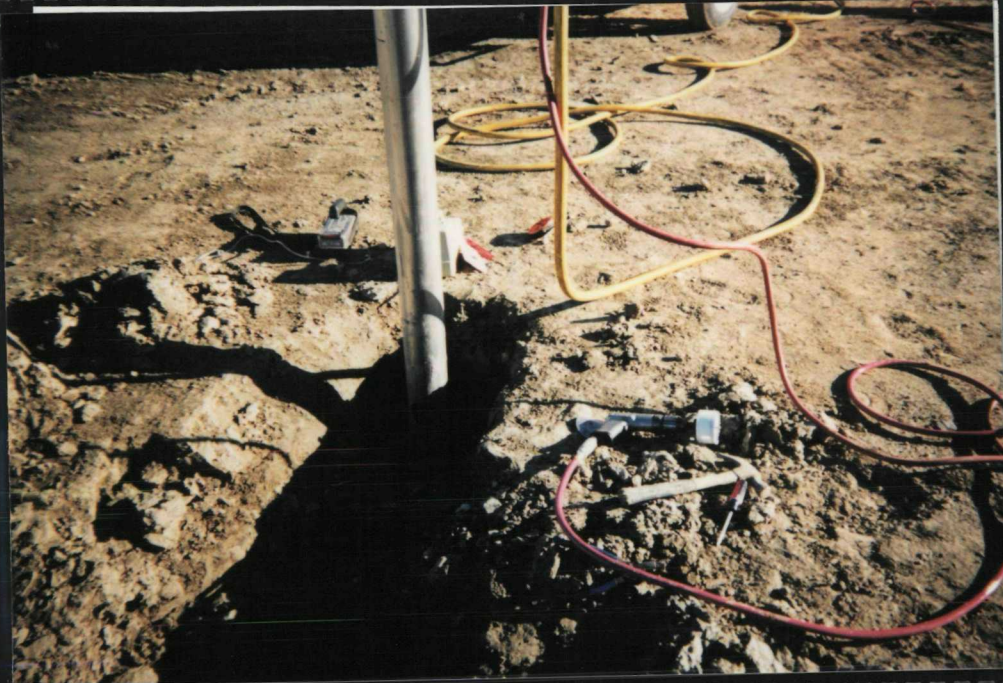
Description: Photo facing east showing hole cut into SVE-31. "Muni-ball" placed into well for inerting process.

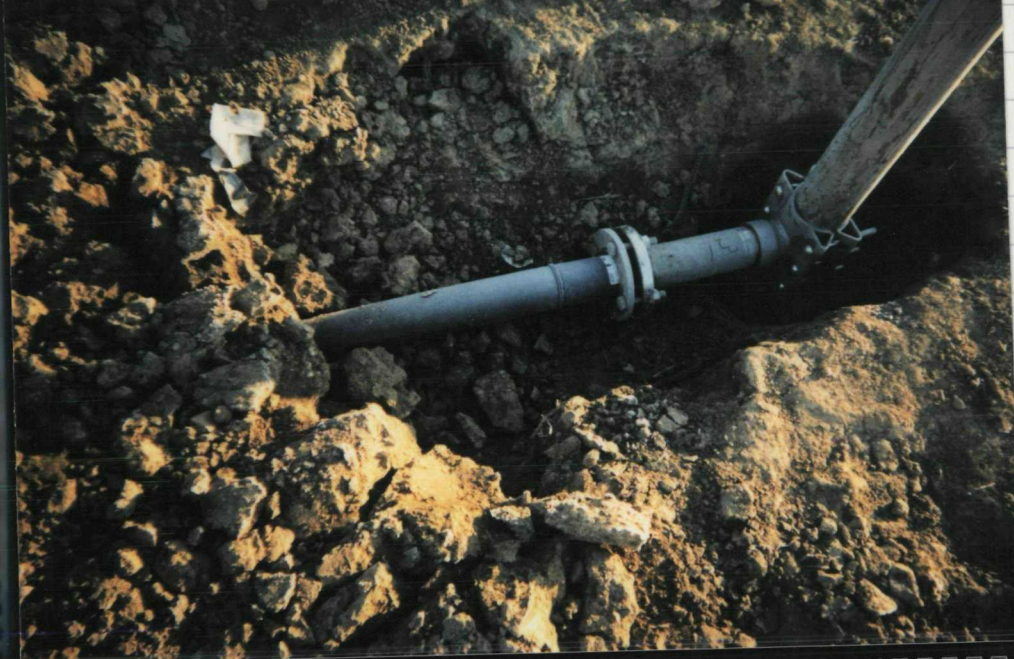
Description: Photo facing northeast showing HDPE piping connection at SVE-31.

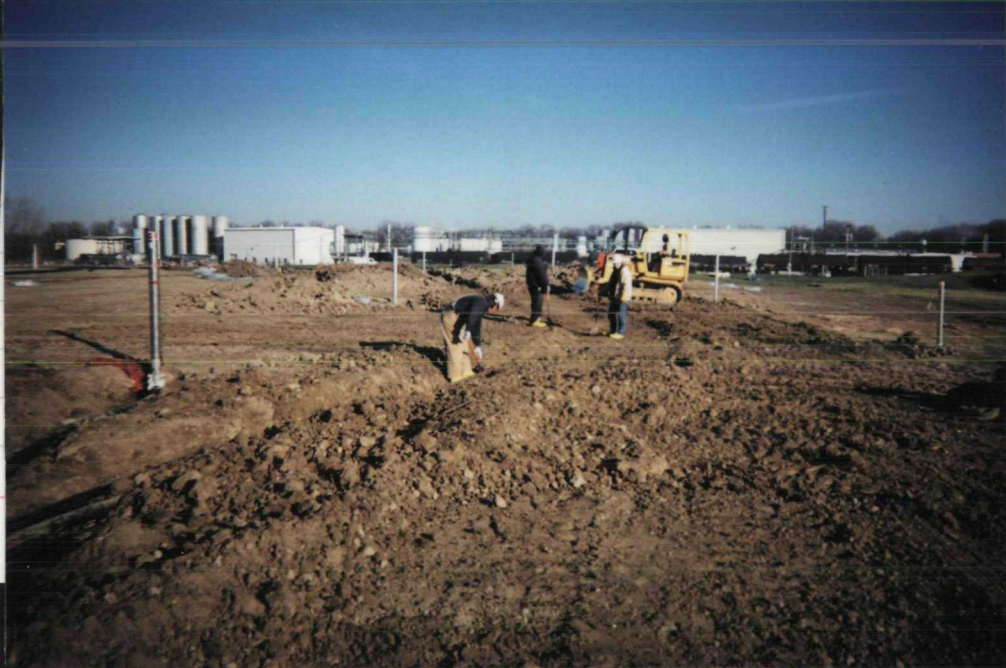
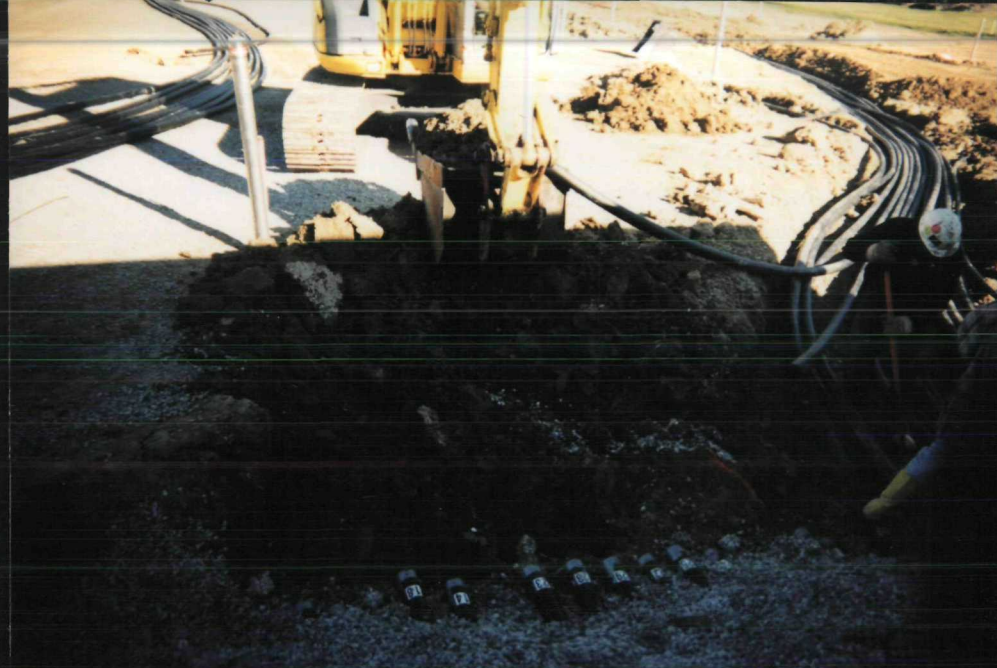
Description: Photo facing north showing piping header at OFCA blower shed and SVE-13.

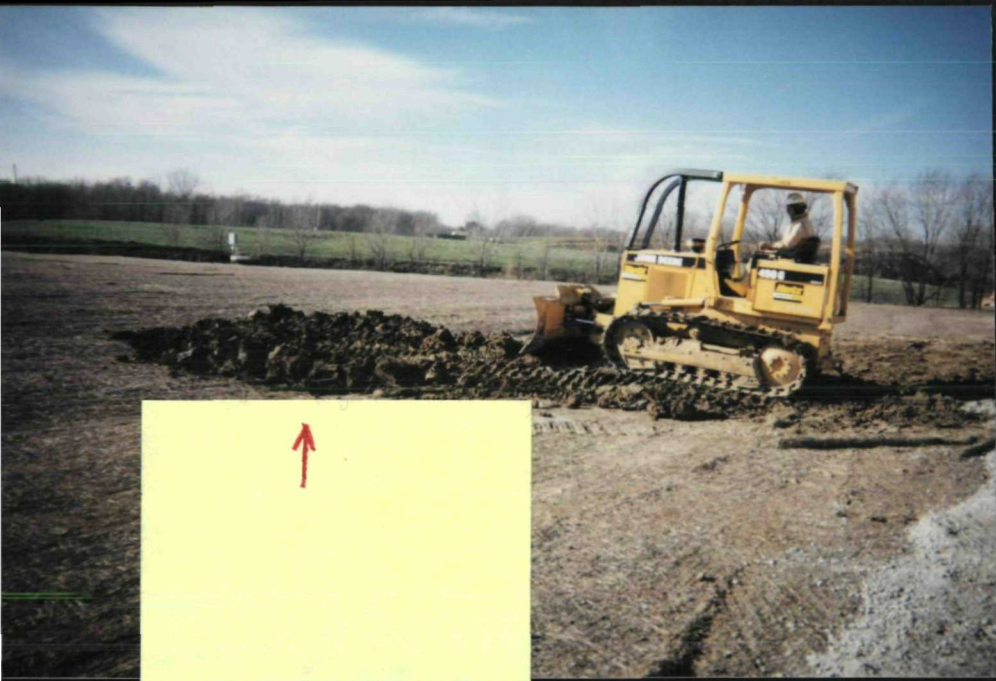
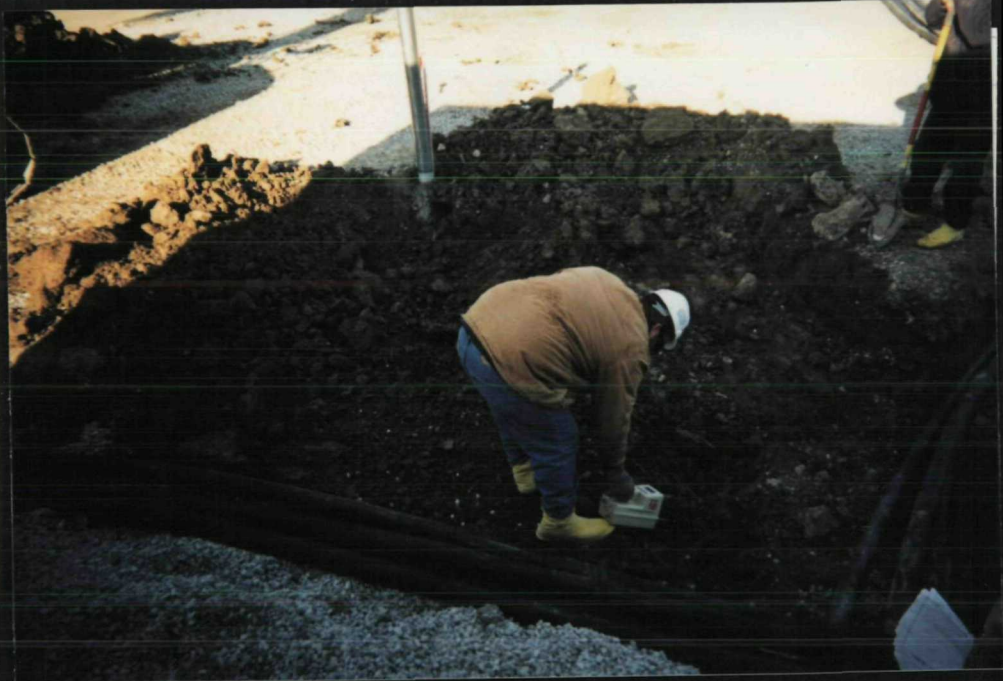
BVSPC observed HIS construct the land bridge over OFCA swale 5. HIS placed a piece of 8-inch-diameter culvert piping underneath the land bridge in order to provide drainage in the swale. For the Kapica-Pazmey (K-P) area piping, the blower shed will serve as the lowest point of the yard piping. During trenching activities, HIS kept the piping at zero grade with the blower shed connections across the land bridge to the K-P area. HIS continued at zero grade through the clay cover until it encountered native material. As soon as the native material was encountered, HIS increased the grade in order to stay at the base of the clay cover. HIS reported that the PID detected a reading of 0.2 ppm during the trenching activities at the top of the native material. HIS replaced some of the clay in order to cover the native material to minimize the potential for vapors. HIS did not detect any other readings with the PID. MWH had three truckloads of clay brought to the site to serve as cover for the ISVE piping that was placed on existing grade in the K-P area. HIS completed rolling the clay in the K-P area on December 21, 2001; however, compaction and moisture testing were not performed at that time.

Site: American Chemical Services, Inc.  
 Proj. #: 46526  
 Roll: 17 Photo #12  
 Date: 12-11-01 Time: 12:35  
 Photographer: Leigh Peters  
 Description: Photo facing west showing HIS  
 constructing land bridge over swale 5.  
 Note placement of 8-inch-diameter  
 culvert piping. (Arrow)

Site: American Chemical Services, Inc.  
 Proj. #: 46526  
 Roll: 17 Photo #13  
 Date: 12-11-01 Time: 13:15  
 Photographer: Leigh Peters  
 Description: Photo facing northeast of excavation  
 between blower shed and SVE-13  
 showing HIS personnel performing air  
 monitoring with a PID.

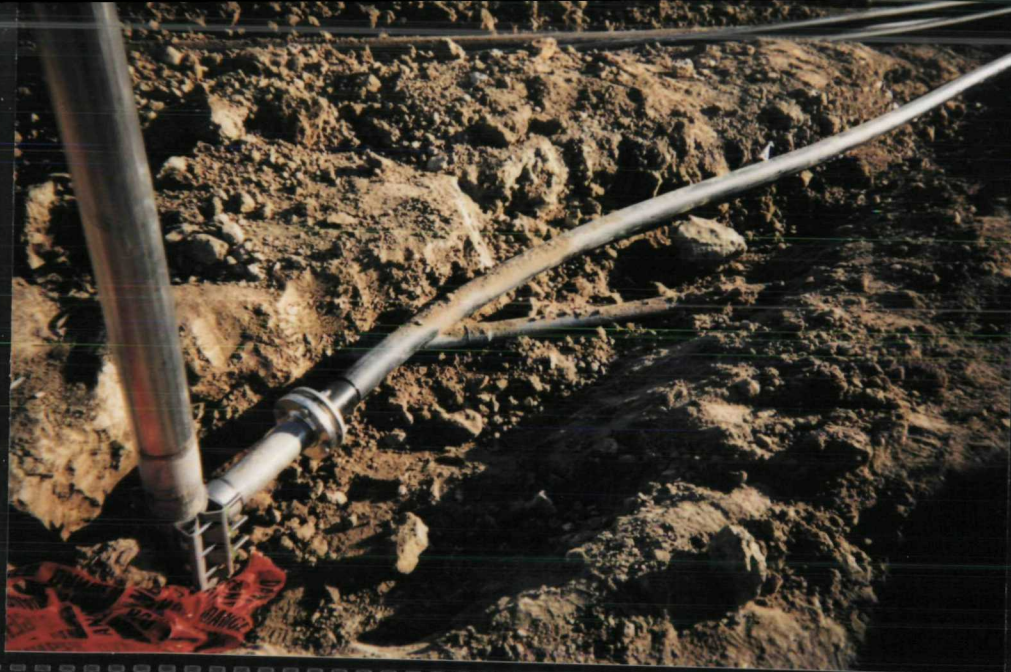
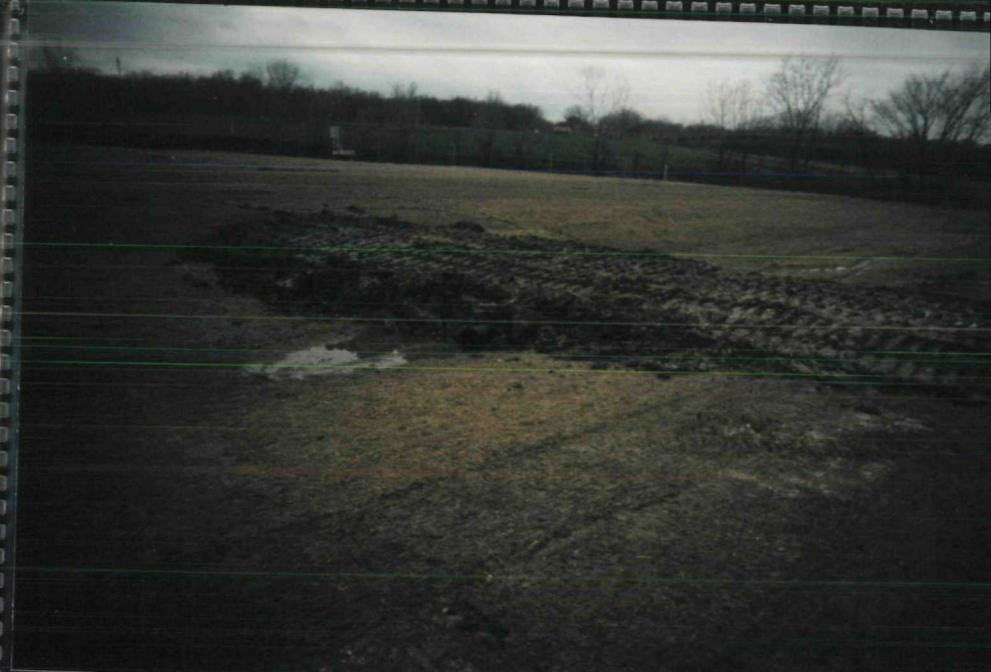
Description: Photo facing southwest showing land bridge over swale 5 and the water collecting in swale upgradient of the land bridge.

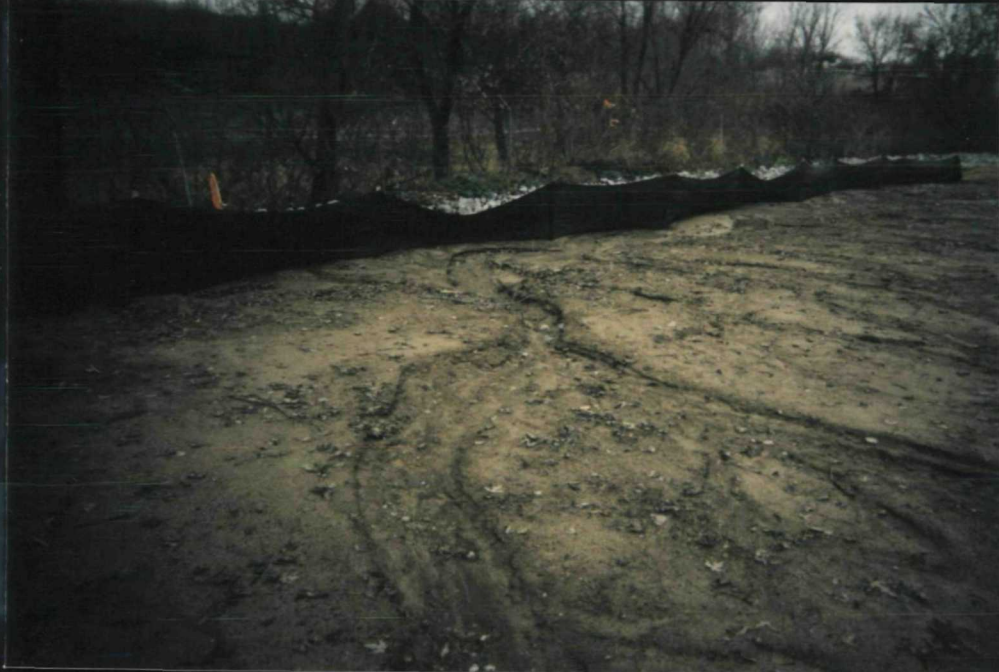
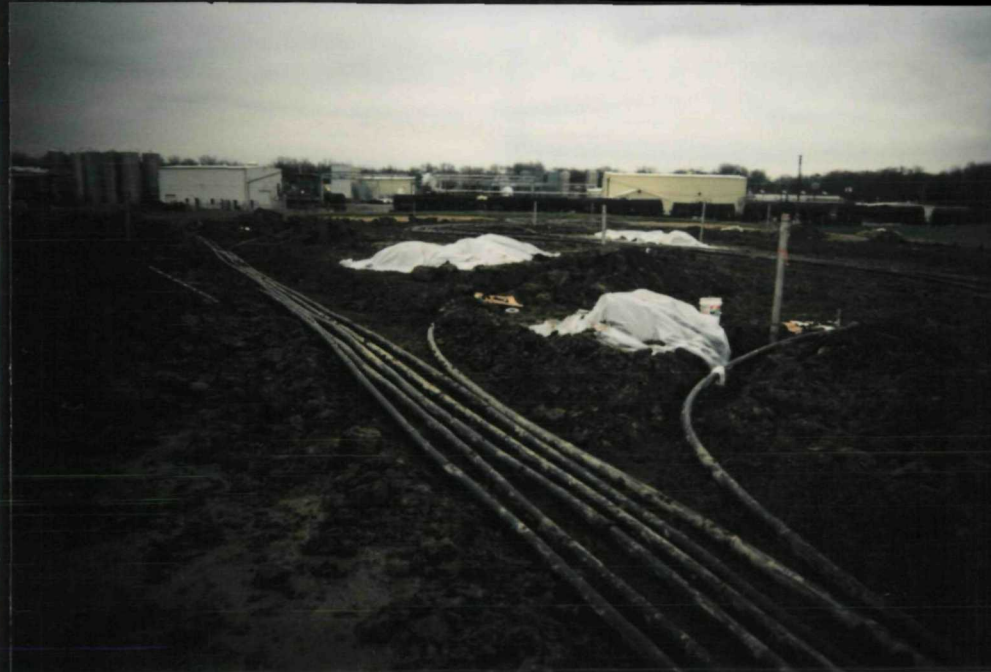
HIS excavated the trench for the central trunk of the OFCA ISVE wells located to the north of the OFCA blower shed. BVSPC observed Mr. Parish conduct continuous air monitoring with a photo-ionization detector (PID). HIS did not observe any elevated readings on the PID during trenching activities. HIS continued to trench within the clay layer. When placing the piping for the central trunk of the OFCA ISVE wells, the piping for SVE-13 crossed underneath the piping to the remaining eight ISVE wells for the central trunk. HIS was not able to lay the piping for SVE-13 without crossing under the other pipes because of the numbering system at the OFCA blower shed.

Description: Photo facing north showing middle ISVE yard piping trench located north of the OFCA blower shed. Material excavated from below clay is placed on visqueen.

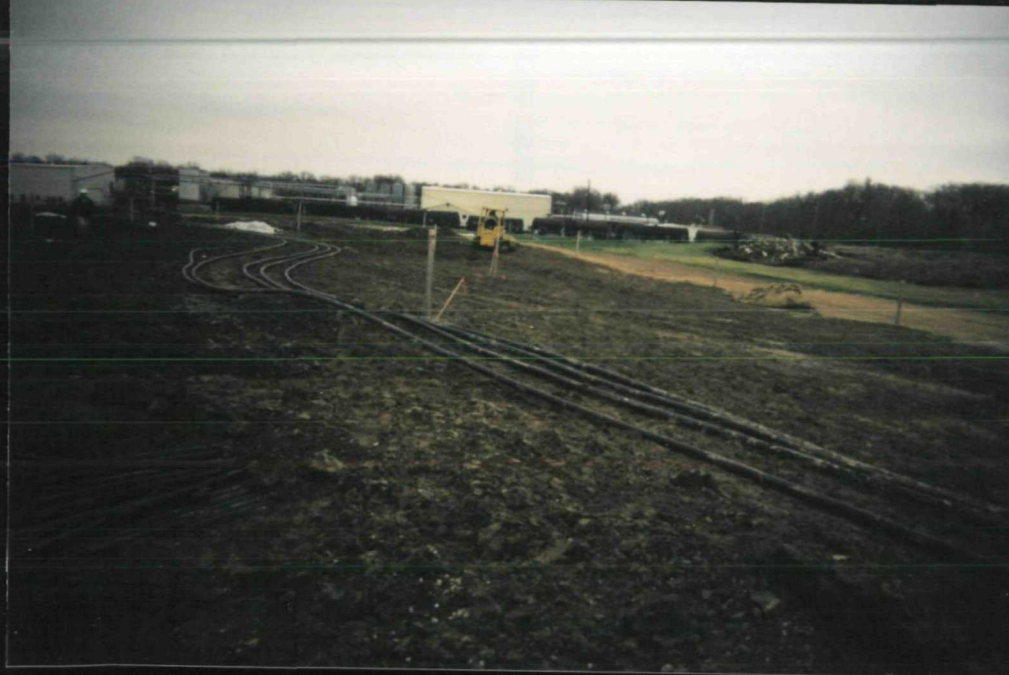
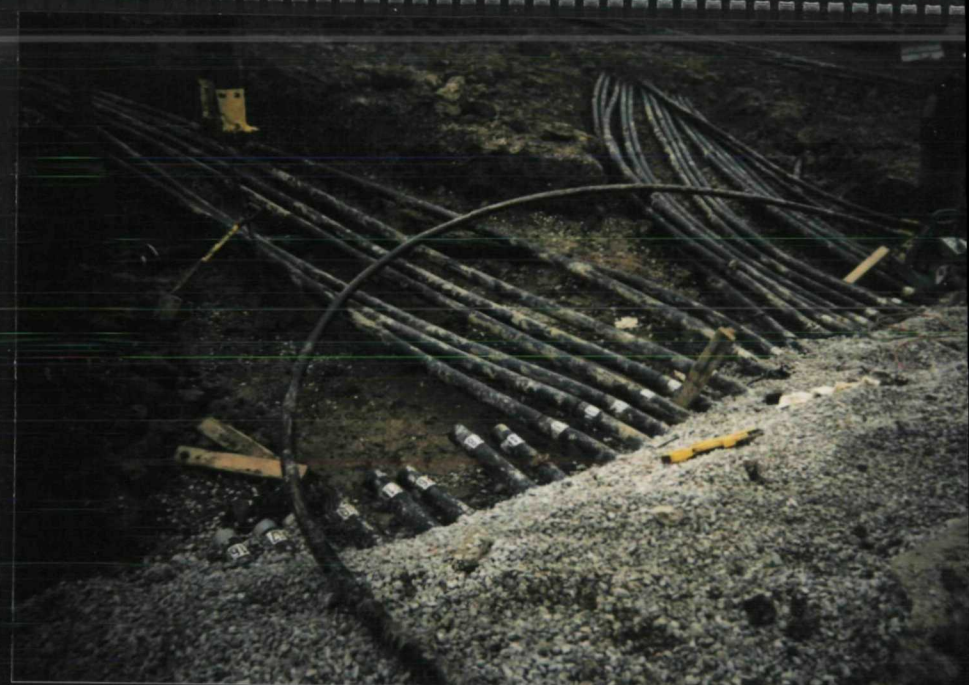
Description: Photo facing northeast showing ISVE yard piping connections at the OFCA blower shed.

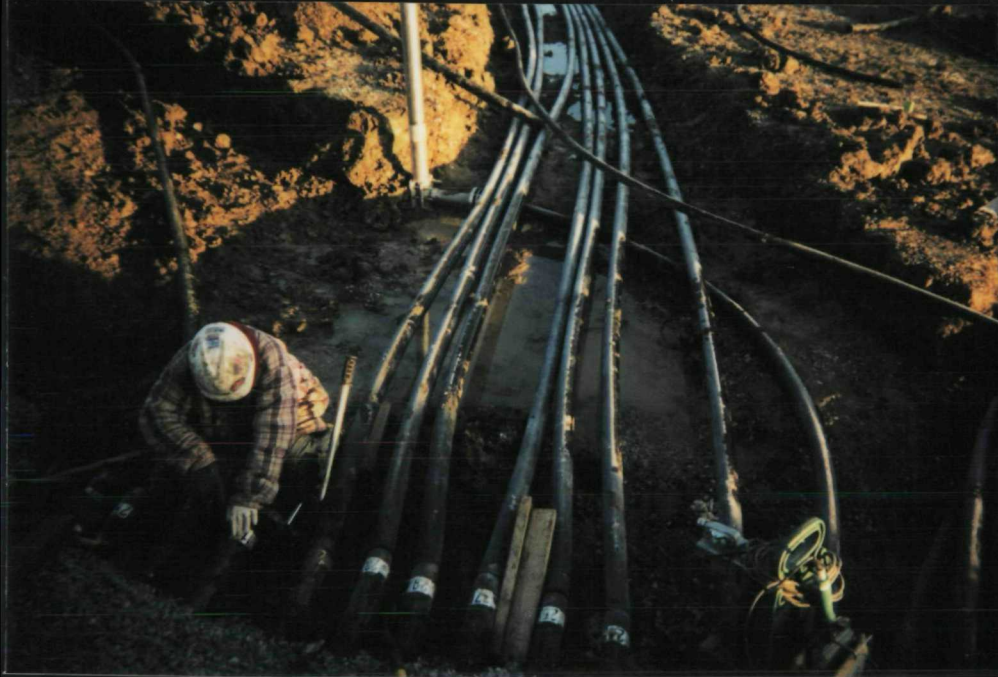
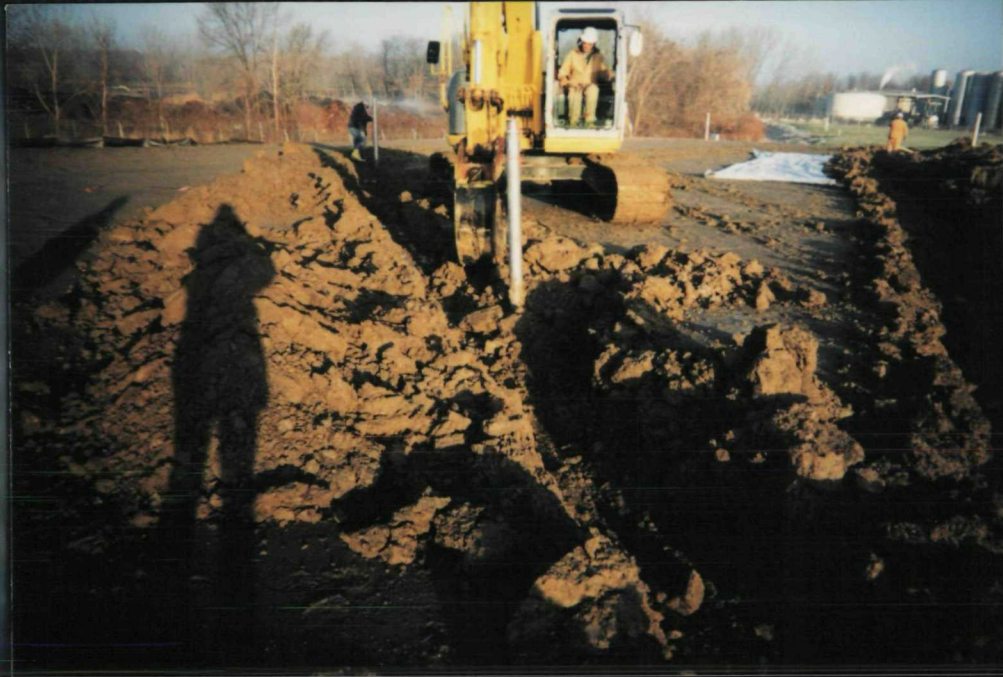
Description: Photo facing northwest showing HIS excavating the trench to SVE-17 around SVE-13.

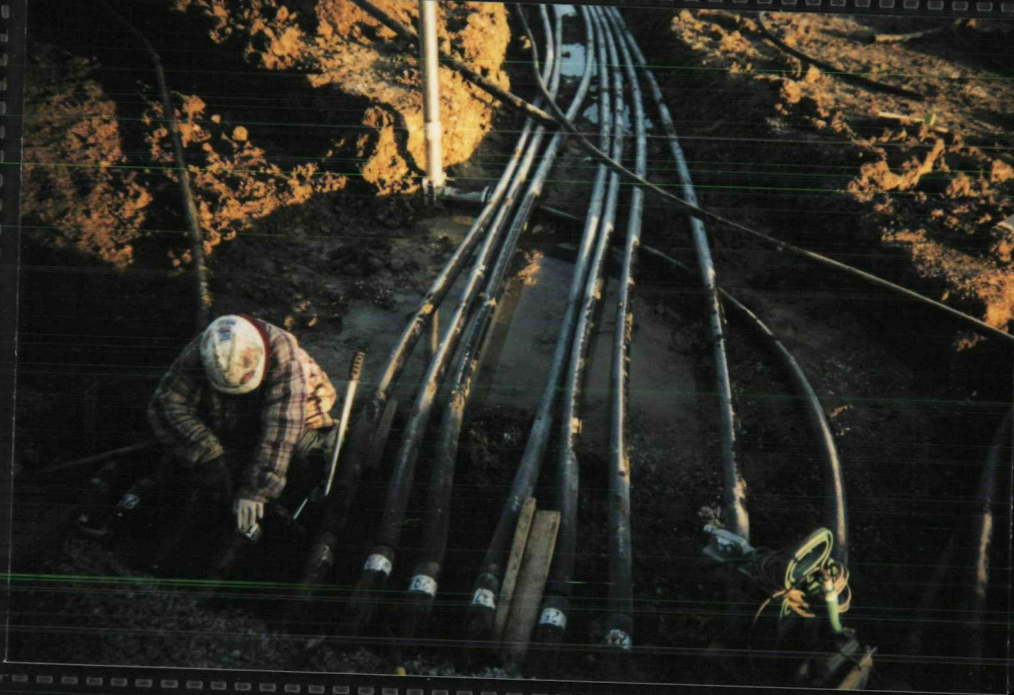
Description: Photo facing north showing HIS welding pipe at OFCA blower shed and connection to SVE-13 that runs underneath the piping to middle trunk.

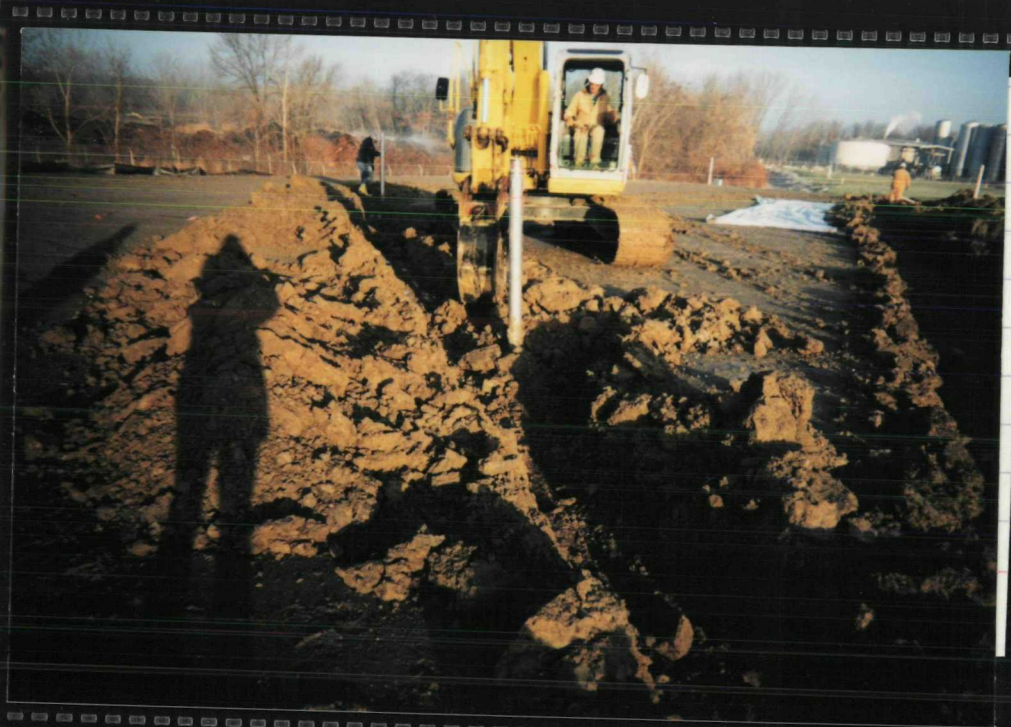
Description: Photo facing northwest showing HIS excavating the trench to SVE-17 around SVE-13.

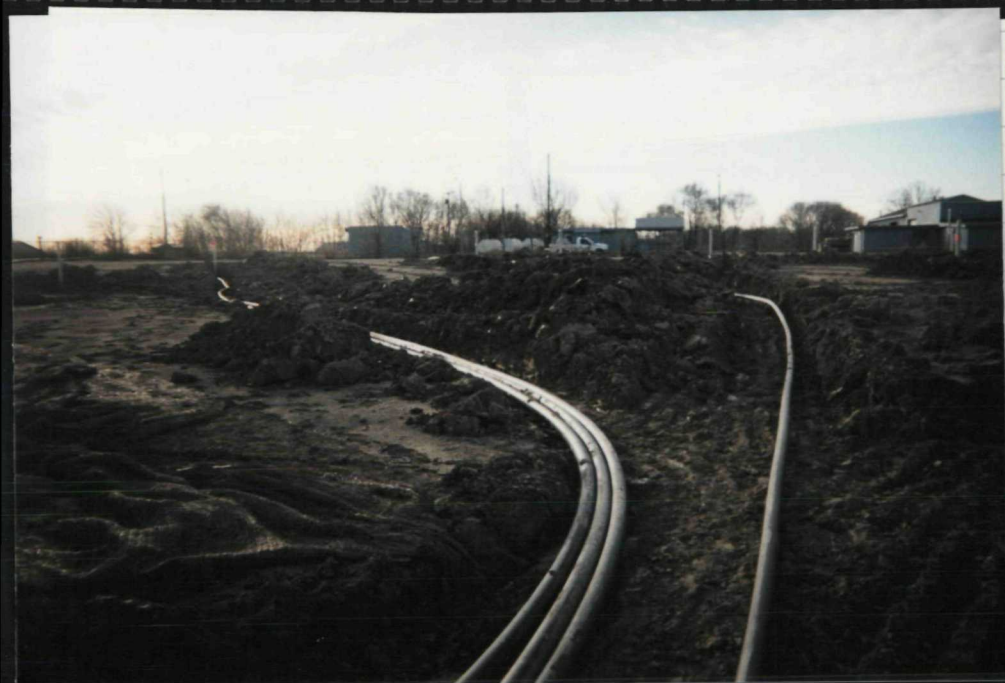
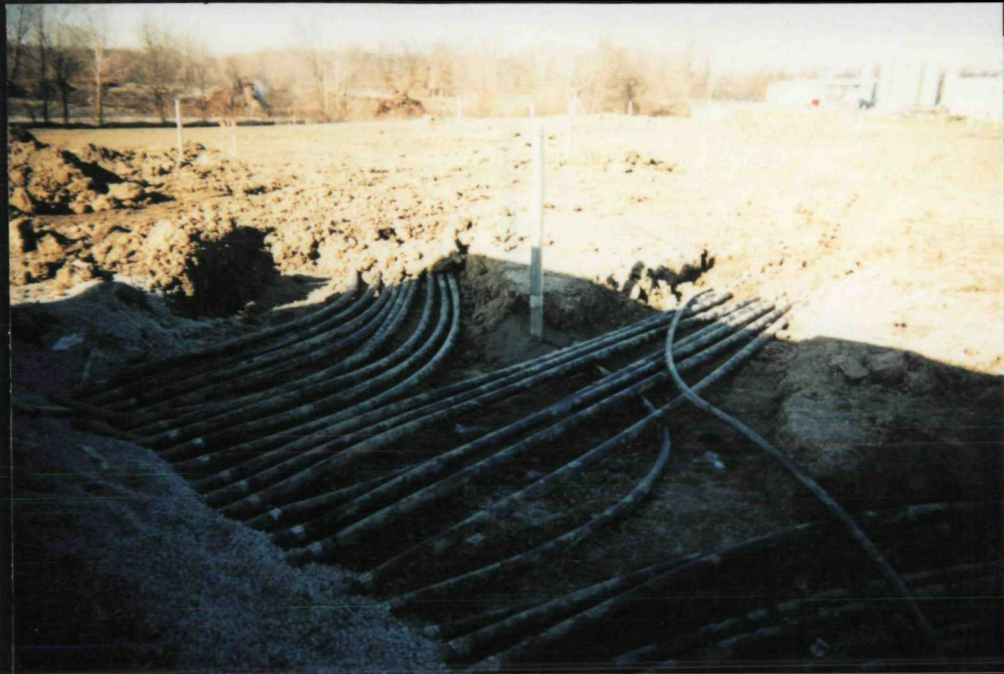
Site: American Chemical Services, Inc.  
 Proj. #: 46526  
 Roll: 17 Photo #24  
 Date: 12-20-01 Time: 09:05  
 Photographer: Leigh Peters  
 Description: Photo facing southeast showing eastern  
 trenches and piping in the K-P area.

Site: American Chemical Services, Inc.  
 Proj. # 46526  
 Roll: 17 Photo #25  
 Date: 12-20-01 Time: 13:30  
 Photographer: Leigh Peters  
 Description: Photo facing northwest showing  
 backfilled trench on western side of  
 OFCA. Note air sparge line placed over  
 piping in the central trench.

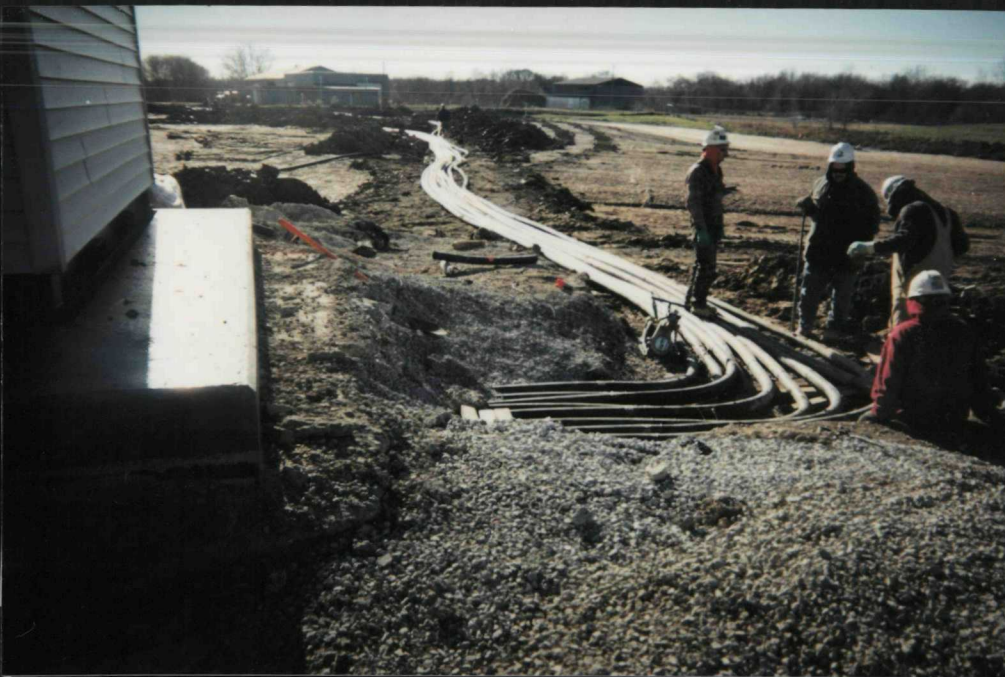
Description: Photo facing south showing HIS working with K-P piping and the piping placed in trench and over land bridge.

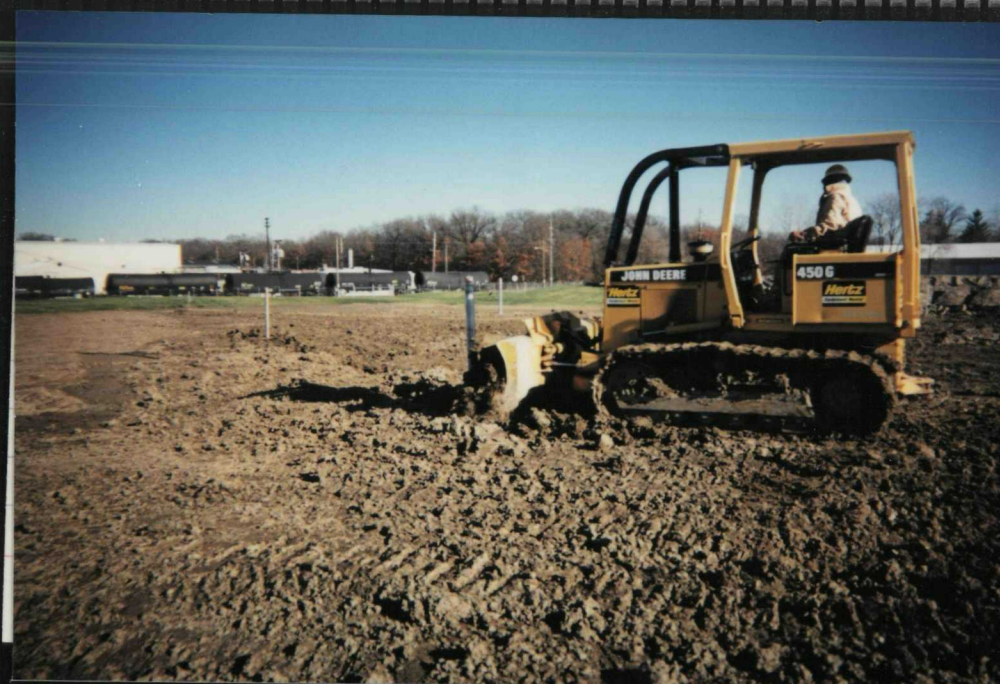
Roll 17 Photo 26 facing south showing H/S working with K-P piping and the piping laid in the trench and over the land bridge. Observed H/S backfill wells north of Blower Shed.
